Volume 2b

Facilities & Campus Analysis

ANALYSIS OVERVIEW

Facility Condition Assessment: Architectural

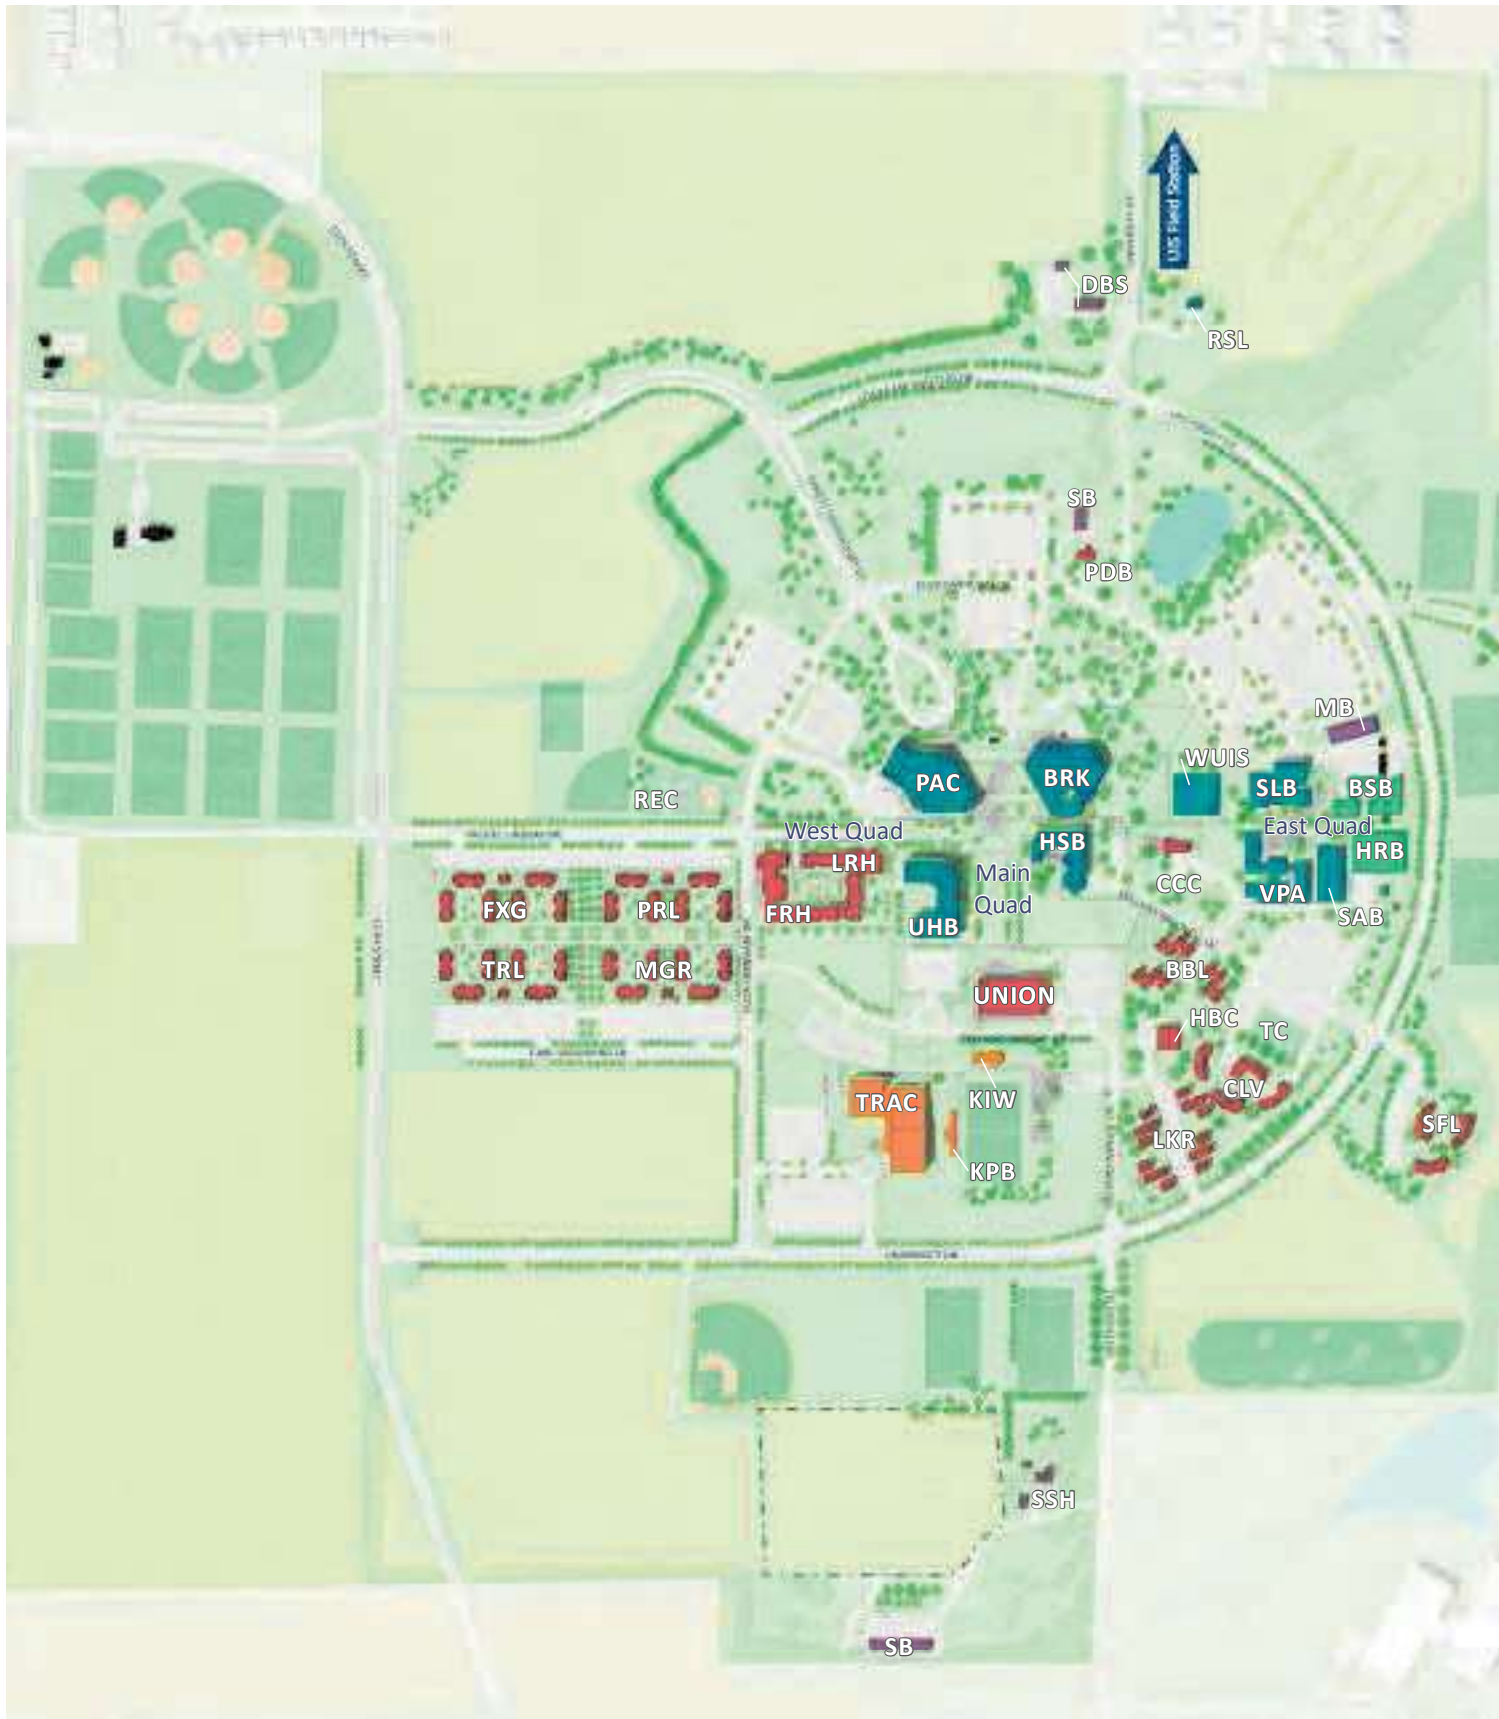
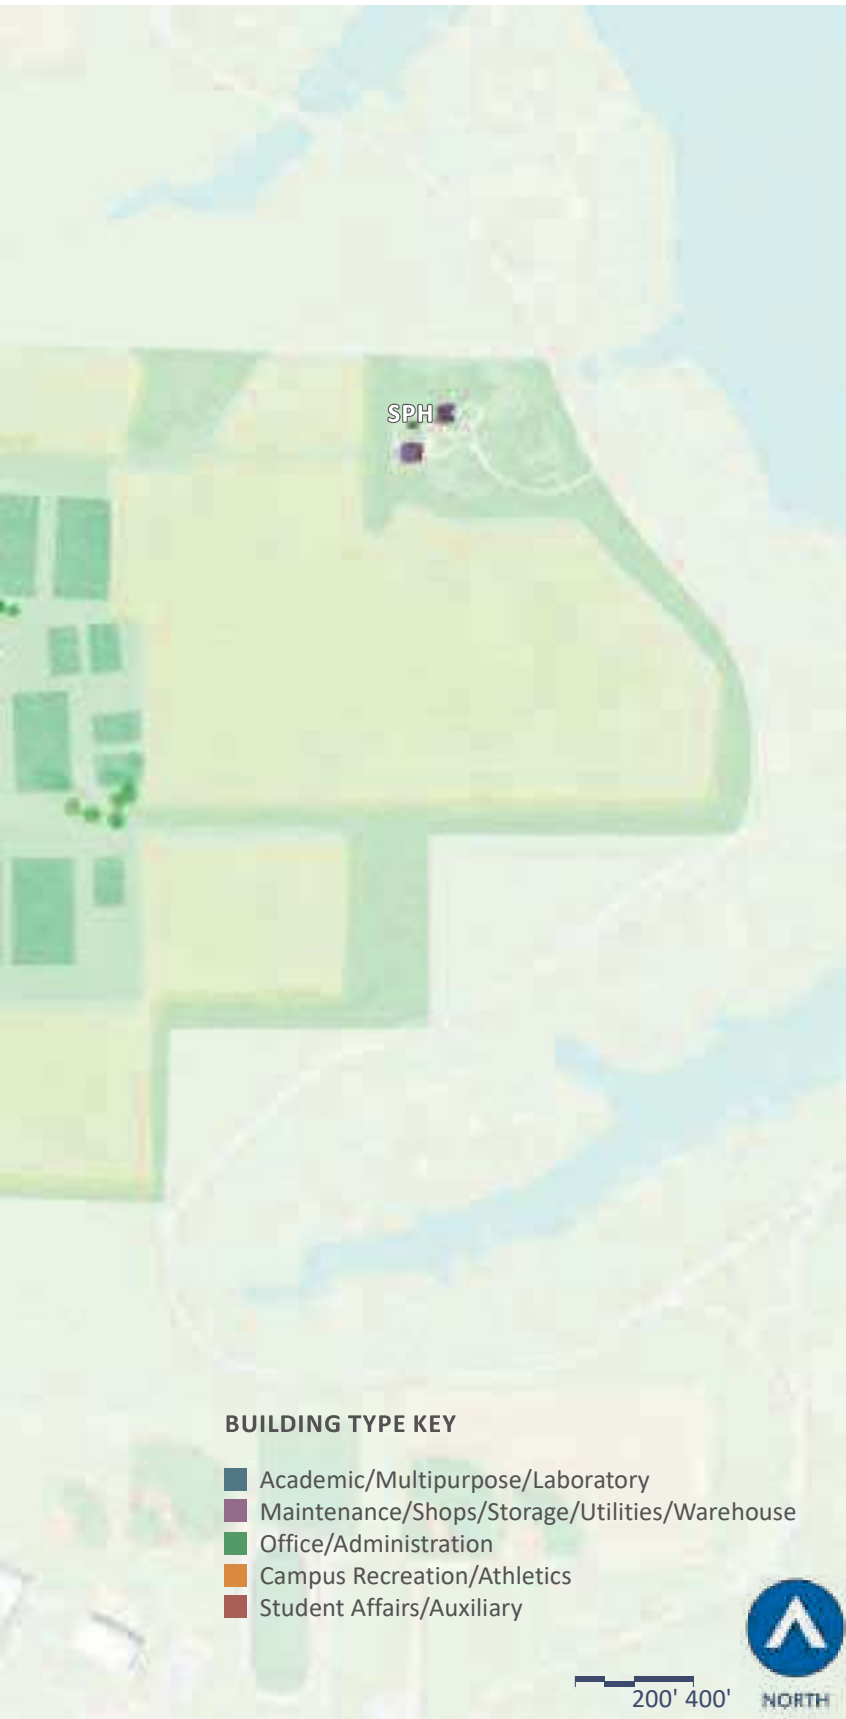
Campus Organization

The University occupies 740 acres, including 1.2 million gross square feet (GSF) among the 86 buildings it owns.

Surrounded by farmland and prairie restoration, the academic buildings are positioned around both the Main Quad and the East Quad. Student housing is largely located to the west and southeast edge of campus, with Athletics and campus recreation to the south.

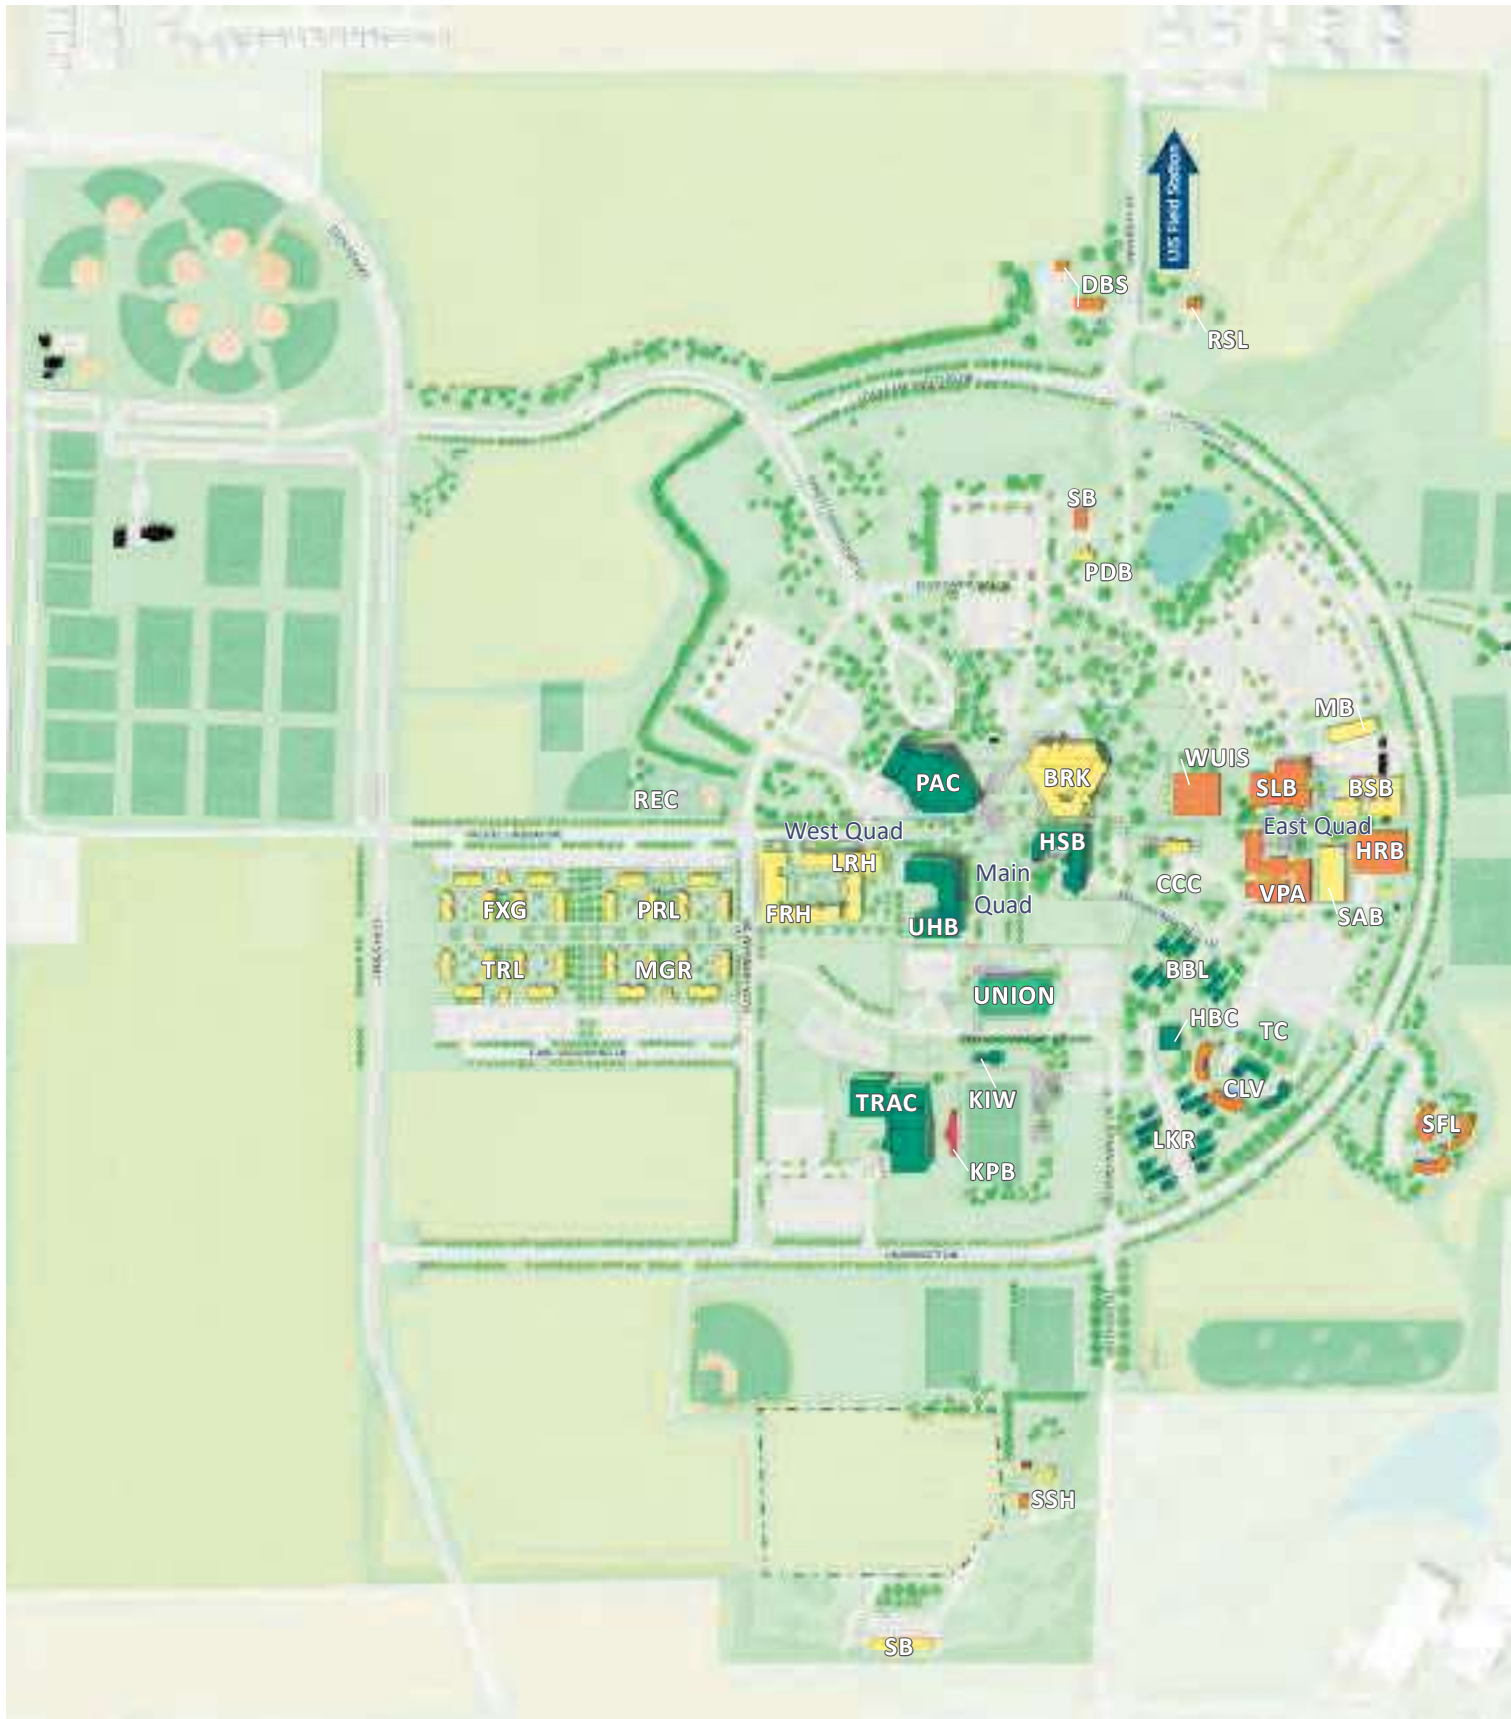
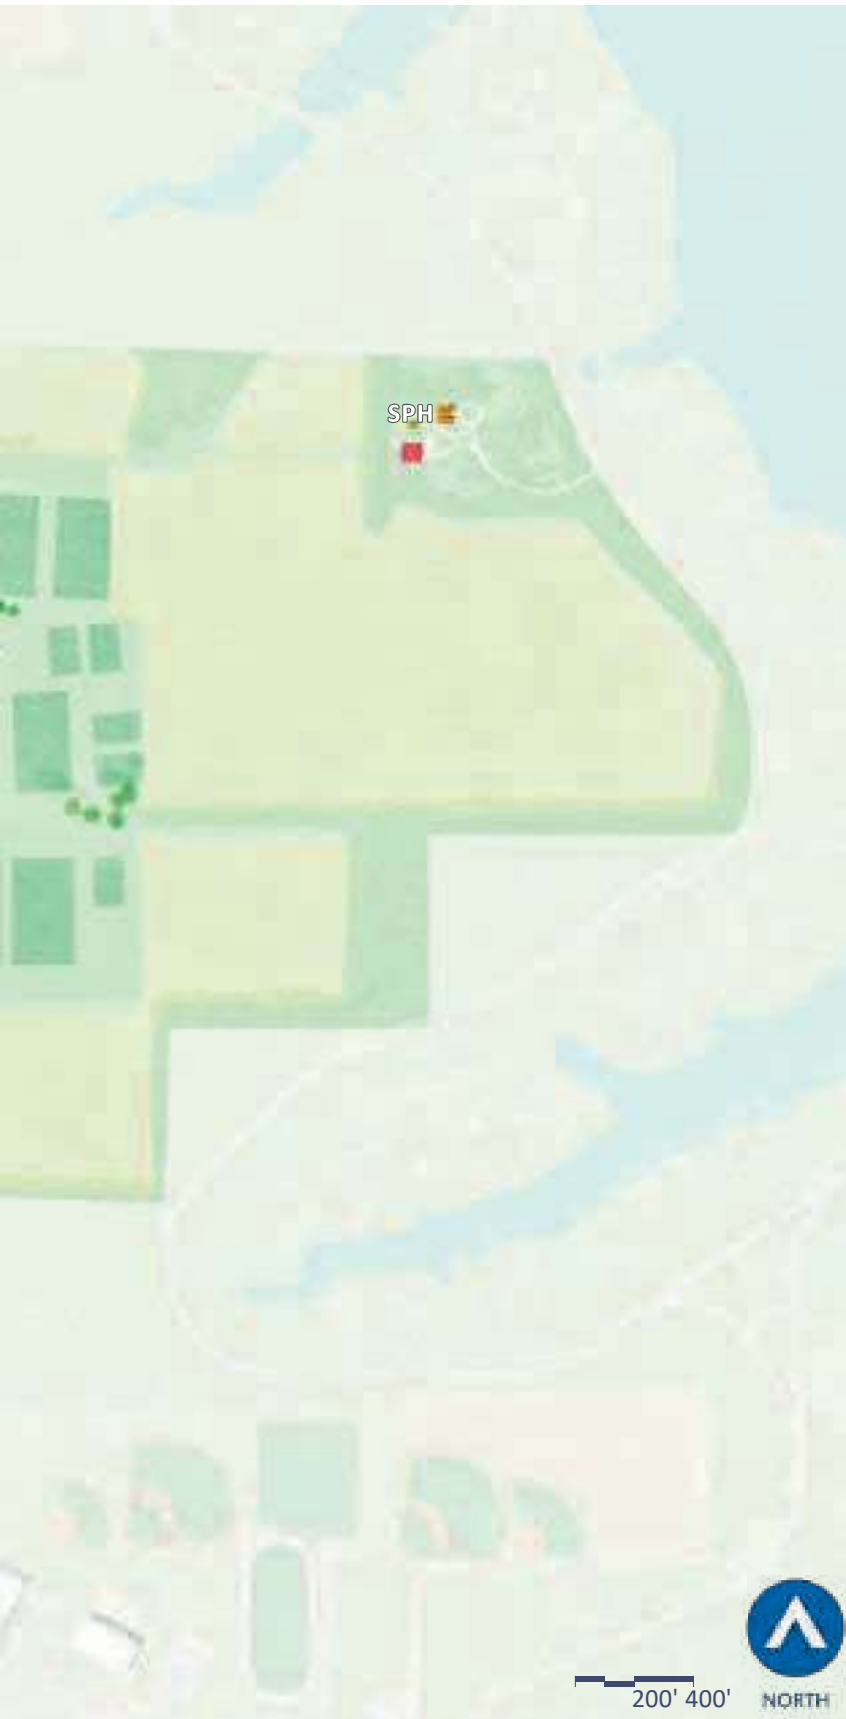
The map to the left illustrates the facility condition rating based on the architectural assessment.

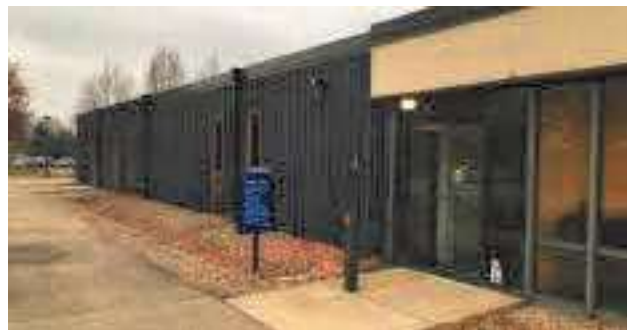
Student Affairs Building

Exterior metal panels are nearing the end of their life with visible denting, discoloration, and rust. EIFS is in need of minor repairs with cracks visible in some places. Sealant joints need to be replaced in most cases. Windows, doors and associated perimeter sealant seem to just need routine maintenance. Interior materials are mostly in good shape with routine maintenance needed. In some cases, lay-in ceilings are worn out and should be replaced. Drywall is mostly in good condition, with minor repair and painting needed.

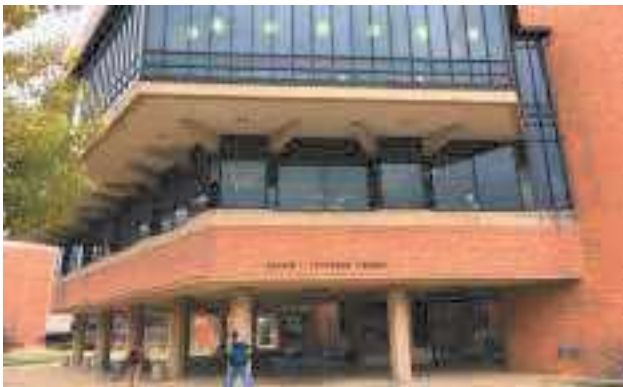
Brookens Library

Exterior masonry is mostly in good condition, with minor maintenance on tuckpointing and sealant needed in isolated areas. Windows and doors are still in good shape, with some minor maintenance required. Most interior materials are still in good shape, though the carpet on levels 2 and 3 of Brookens Building needs to be replaced, and some lay-in ceilings are worn out in isolated areas. Drywall is in mostly good condition, with

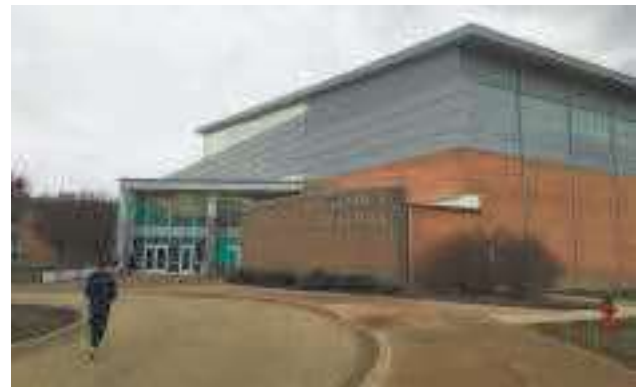
The Recreation and Athletic Center

Both of these buildings are in very good condition. All interior and exterior materials are still fairly new and only need routine maintenance. The Kiwanis Press Box is an exception to this. The Press box is in poor condition, and is in need of replacement.

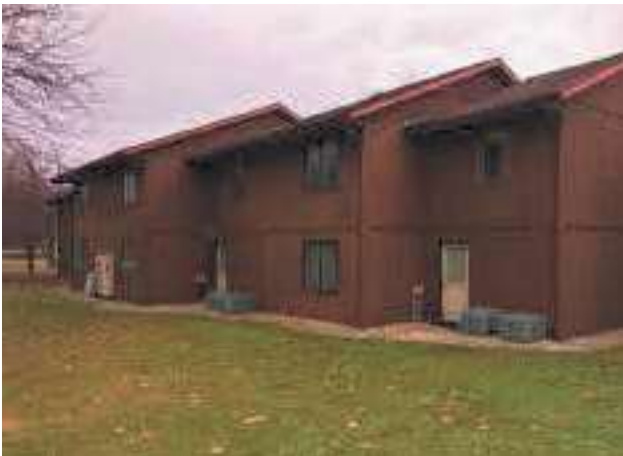
Most of the East Campus housing buildings have been renovated recently. These buildings are in good condition and need only routine maintenance at this time. The only exceptions to this are the buildings in Sunflower Court, and two buildings in Clover Court, which need major repair to exterior siding, exterior windows and doors, and roofing.

Clover Court Apartments
Photos courtesy of Lawrence Group

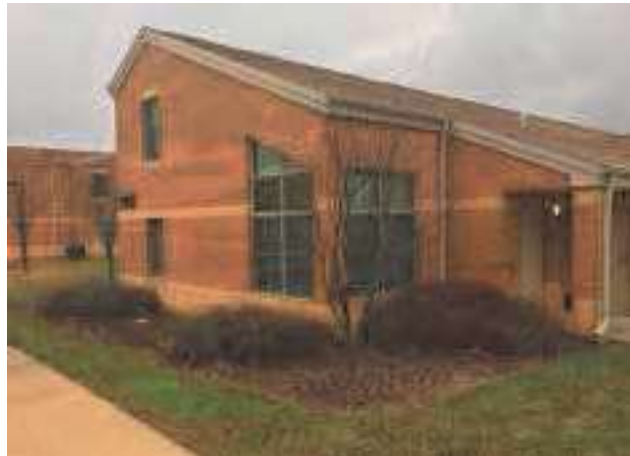
Trillium Court Apartments

These buildings are in good condition on the exterior. Masonry is in good shape with no tuckpointing repair needed. Some minor sealant repair is necessary. Windows and doors are in good condition. Roofs have no visible damage and seem to be in good shape. Interior materials are starting to show signs of wear, but still appear to have life left with minor repairs. Drywall is in good condition with minor repair and painting needed. Several window sills with a reverse slope catch and hold water.

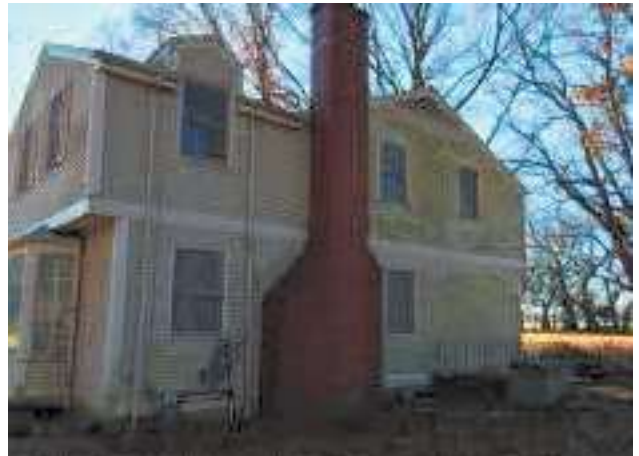
The Spencer House complex in particular needs repair or replacement. Siding shows extensive mold growth, window and door trim is in poor condition and sealant needs to be replaced, the masonry chimney needs to be tuckpointed, and interior materials are in poor condition.

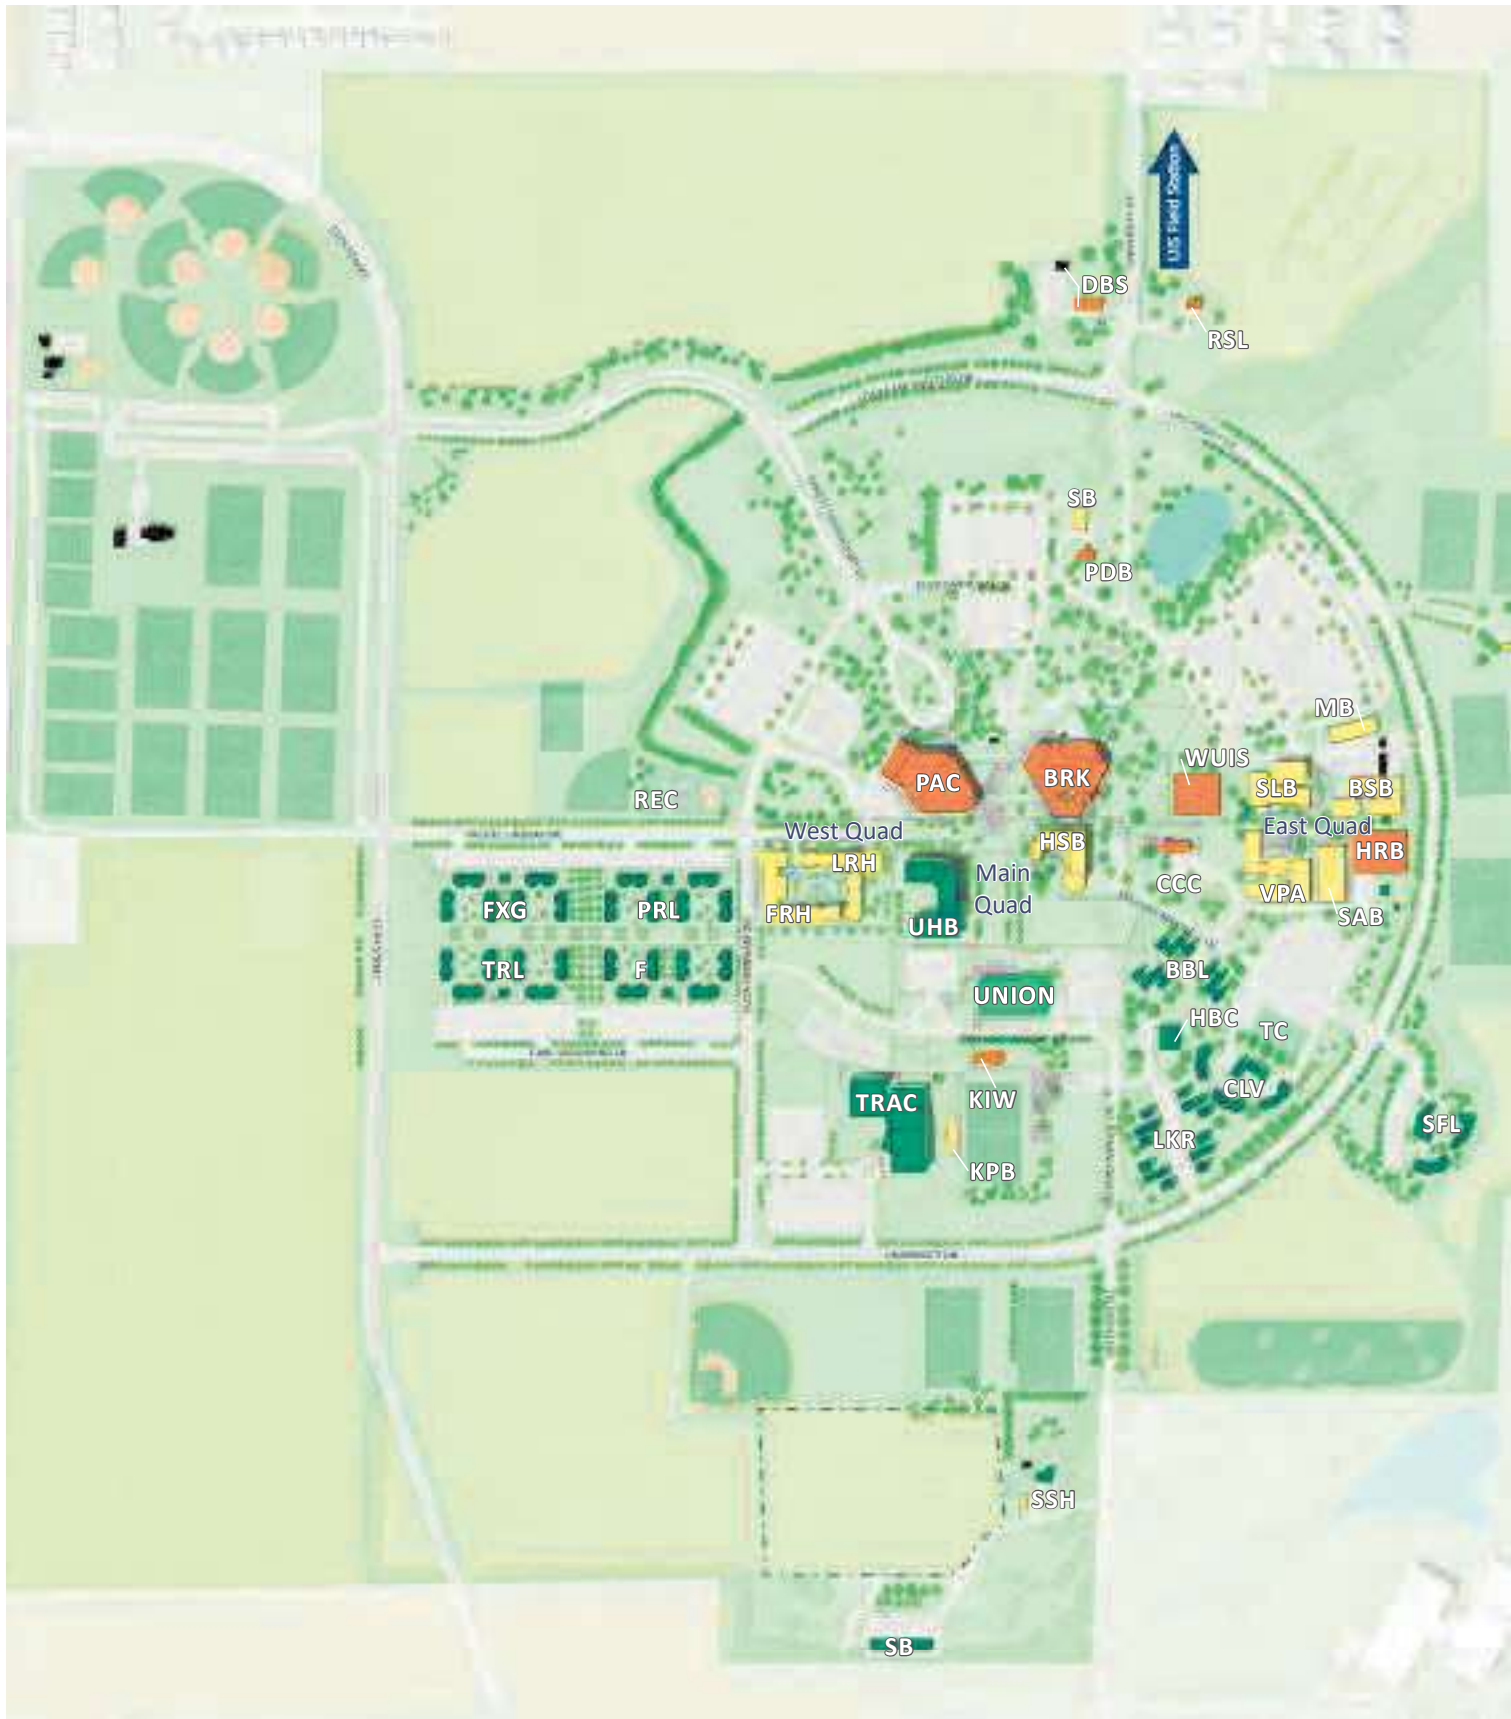
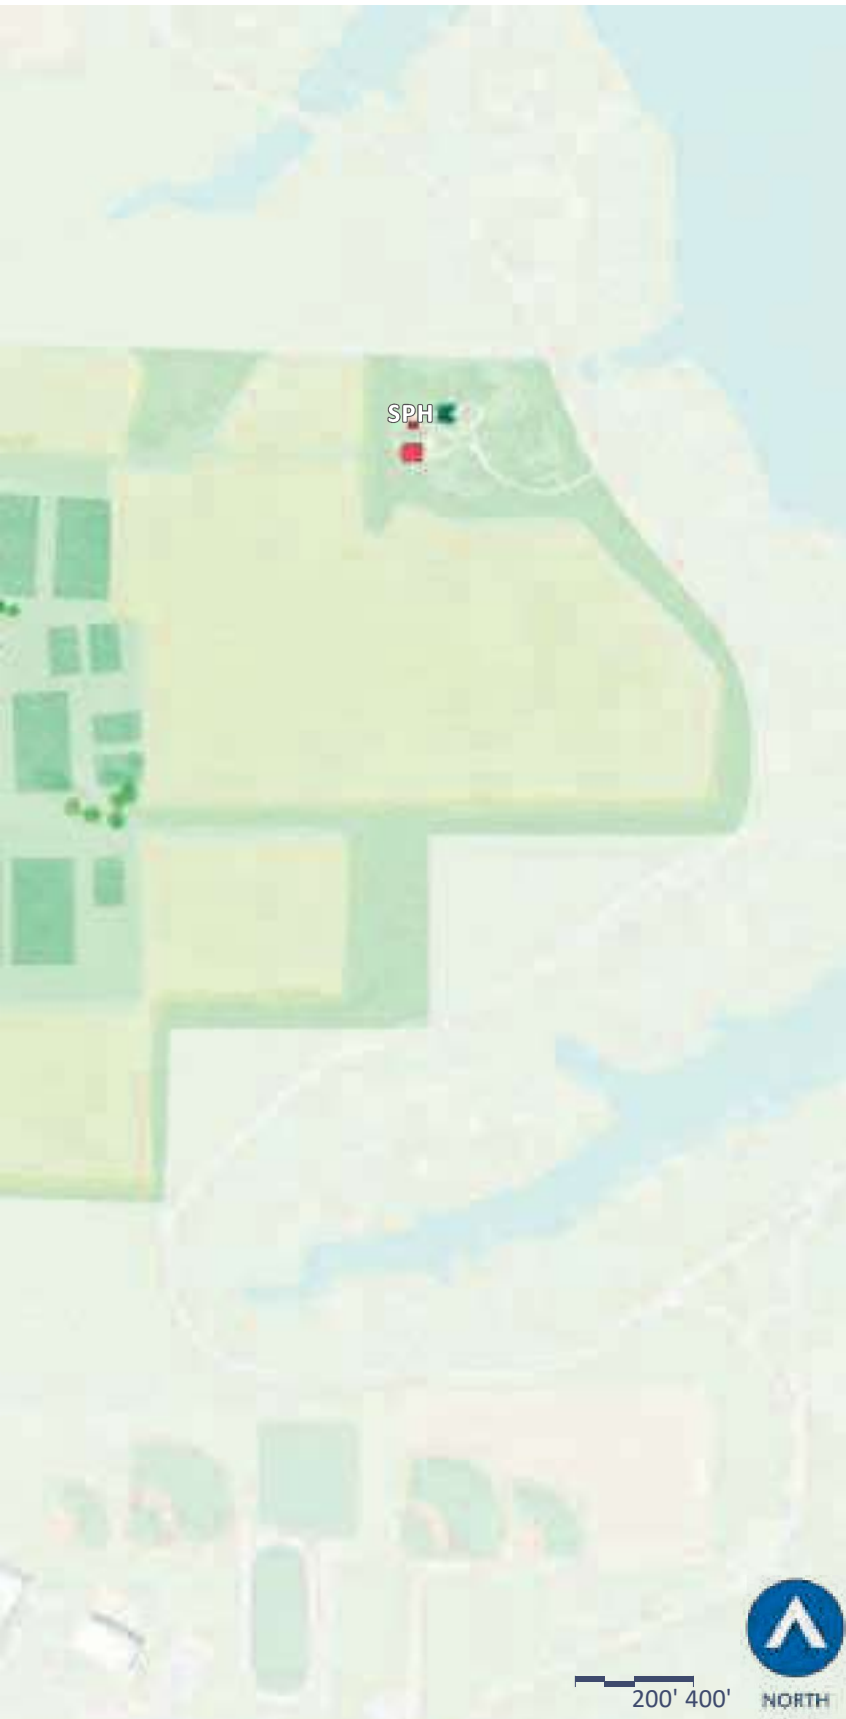
Facility Condition Assessment: Mechanical, Plumbing, Fire Protection, Technology

The map to the left illustrated the facility condition rating based on the Mechanical, Electrical, Plumbing, Fire Protection, and Technology assessment.

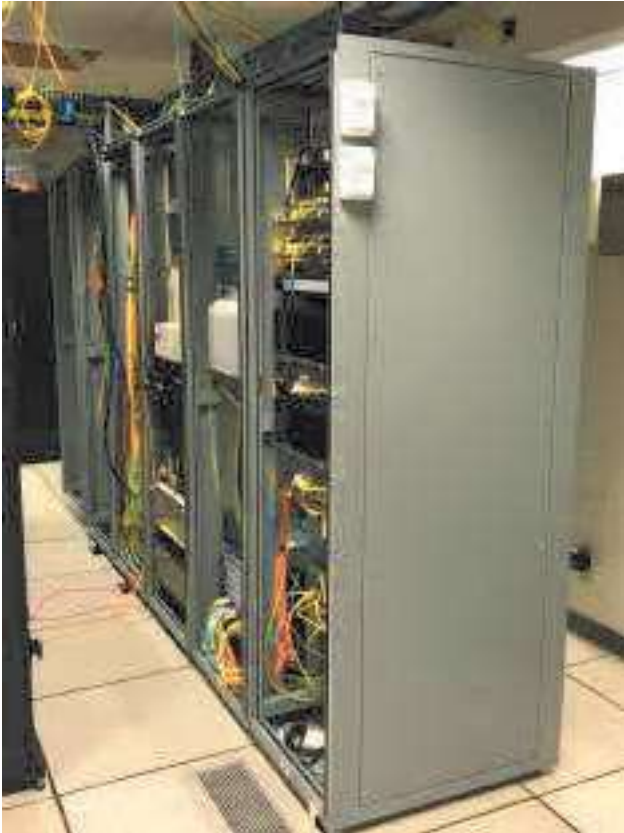
Technology Equipment at HSB

- Primary is in HSB.
 - There are science labs above the data center. This is a concern for water and other liquids leaking into the data center.
 - There have been some recent upgrades to the Uninterruptible Power Supply and cooling systems.
 - Mechanical and electrical systems are fully redundant.
- University Hall is the redundant data center.

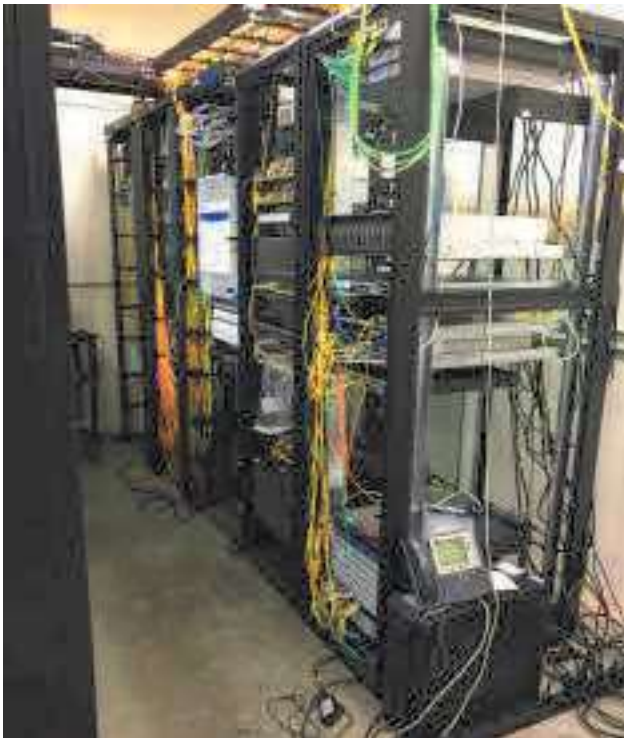
Technology Equipment at UHB
Images Courtesy of IMEG.

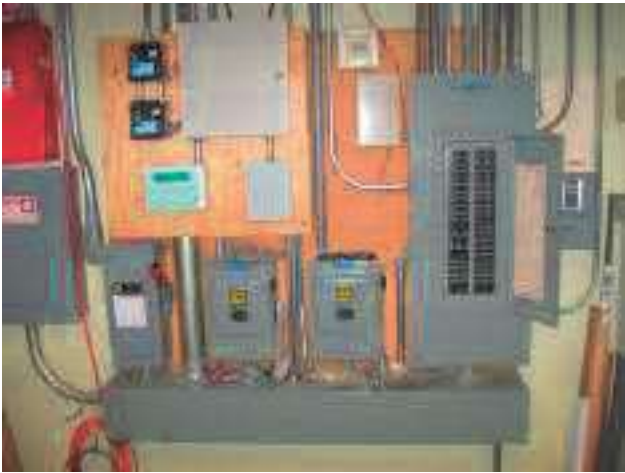
Electrical Equipment at Legacy Campus

- All the main campus buildings are fed from their primary system including the buildings around the East Quad. The apartments, townhouses, and Cox Children's Center are fed from Springfield City Water, Light, and Power (CWLP).
- Most of the electrical equipment and outlets are original to when the buildings were built with very little replacement. Some of the townhomes/apartments (Bluebell Court, Larkspur Court, Clover Court) were completely renovated on the interior in 2012.
- Most of the lighting is in good shape and mostly T-8 type fluorescent lighting with some LED, Compact fluorescent, HID, and Incandescent lighting.
- The fire alarm systems appear to be in good shape with some of the main Simplex panels needing replacement due to obsolescence.

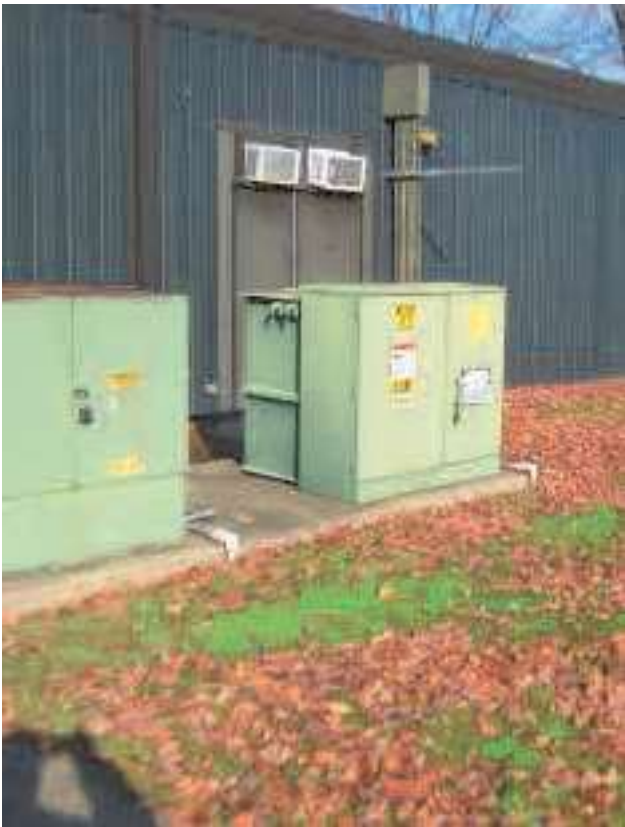
Electrical Equipment at Legacy Campus

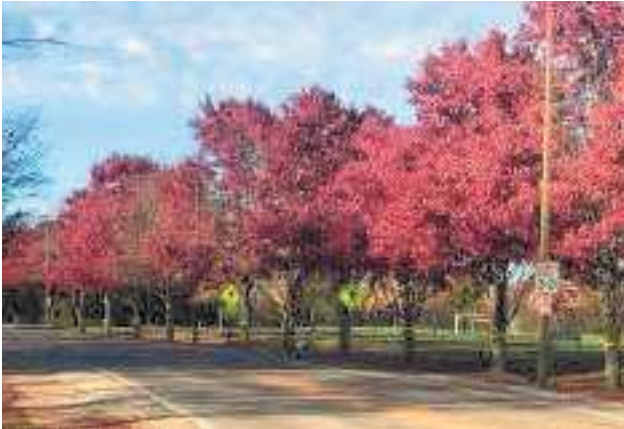
Photo of advanced crossing signage provided for key park/trail crossings on Edgar Lee Masters Drive/Ring Road

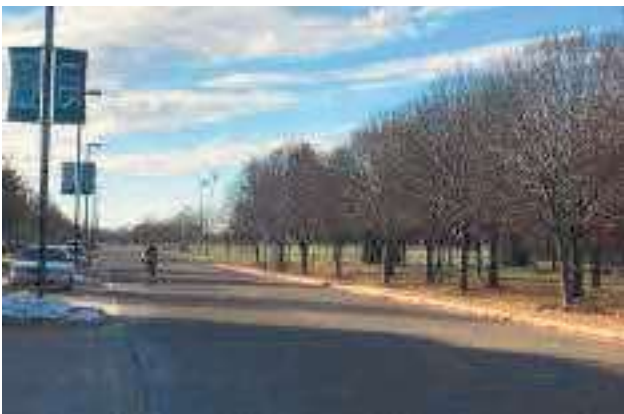
Photo of cyclist on Vachel Lindsay Drive approaching the UIS campus, Bike lanes are not currently provided on Vachel Lindsay Drive

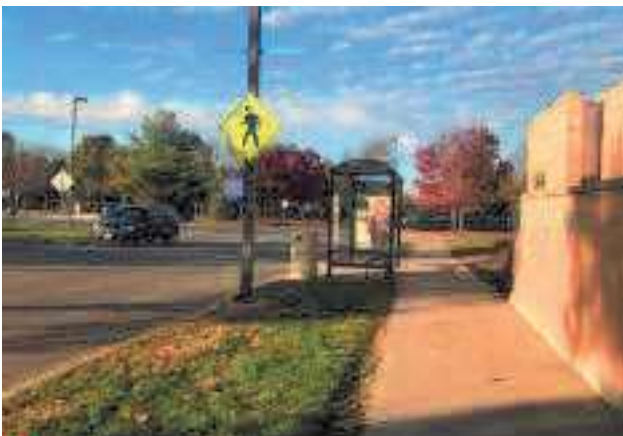
*Photo of transit shelter outside Founders Residence Hall. Route 11 and Route 15 both stop at this shelter
Photos courtesy of Kimley-Horn*

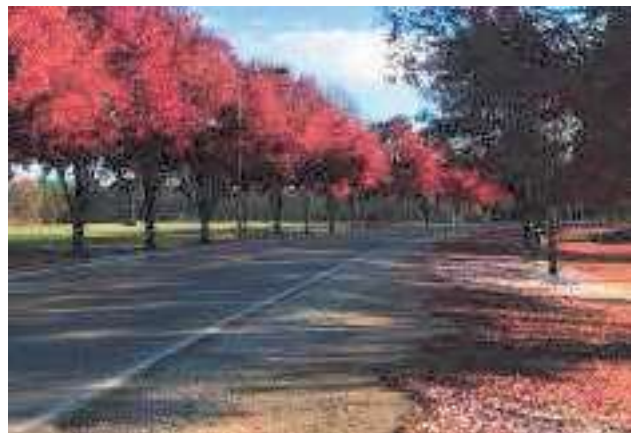
Photo of two-lane cross-section with paved shoulder on the east side of campus, along Edgar Lee Masters Drive/Ring Road

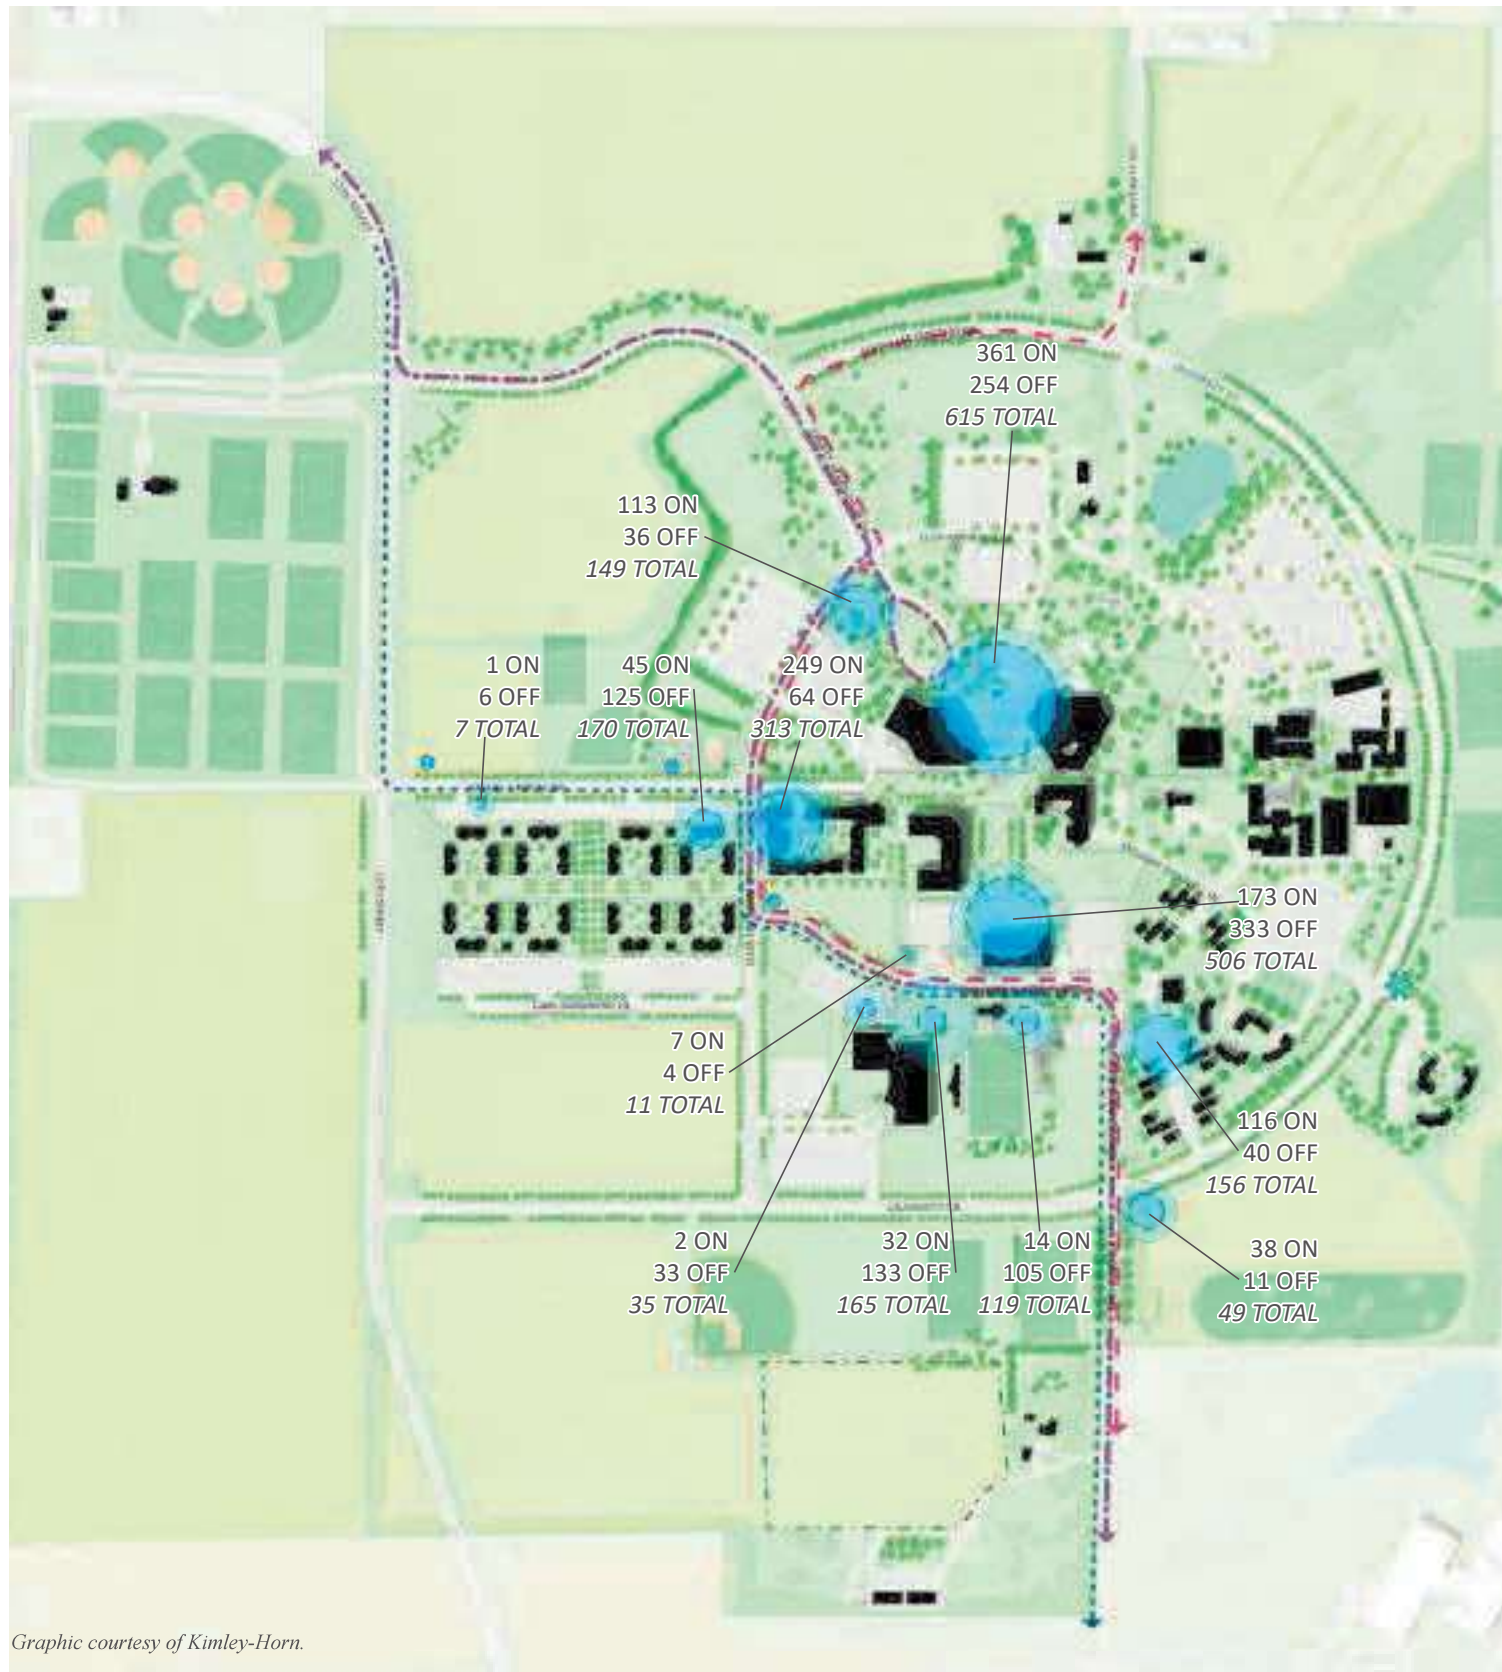
Exhibit 5: Average Monthly Transit Ridership

SMTD recently installed a new data collection system on buses serving the UIS campus. Based on data available for April and May 2019, a summary of average month boarding and alighting data for existing campus transit stops is presented in Exhibit 5. As shown in this exhibit, transit stops near the Public Affairs Center and Student Union experience the highest demand. In contrast, a number of stops on campus are currently underutilized.

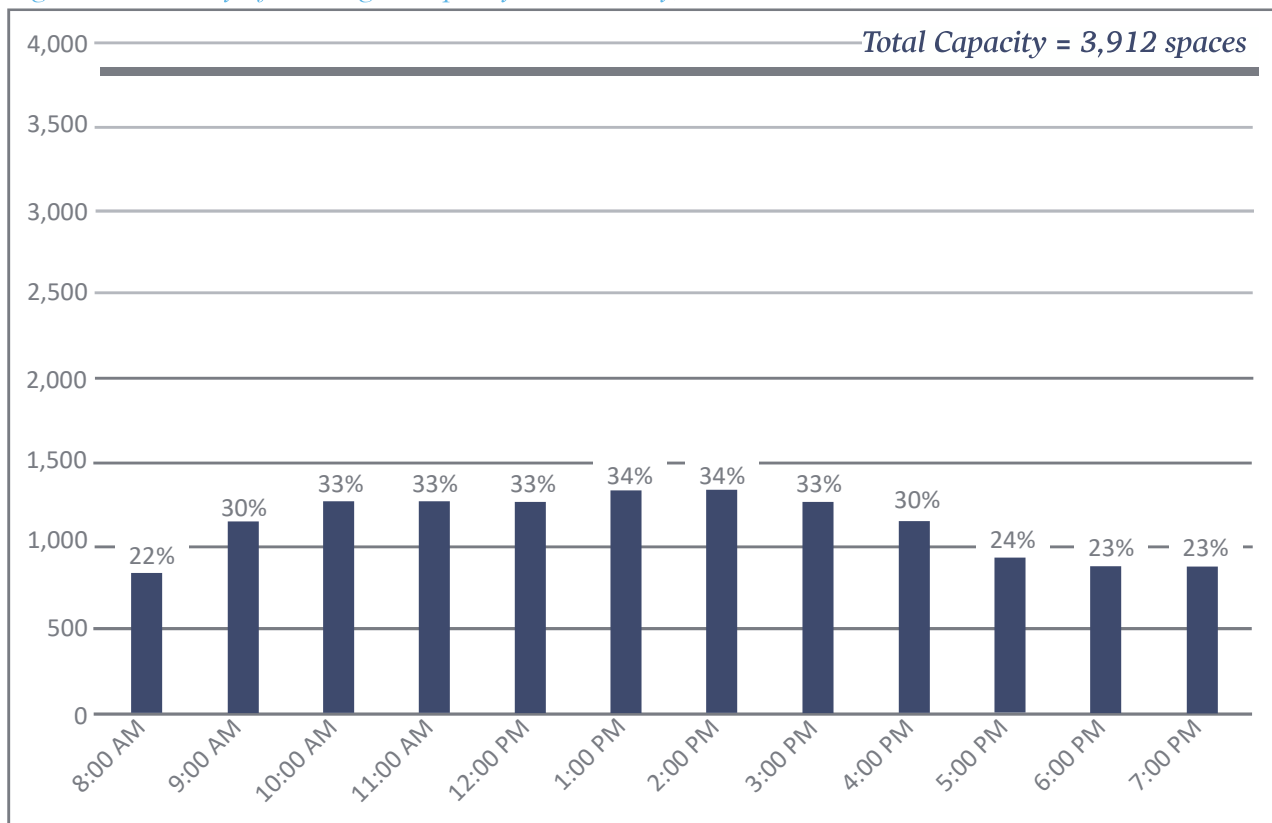
Figure 3: Summary of Parking Occupancy - Wednesday, November 14, 2018

While the overall peak parking utilization was 34 percent, there are individual lots which experience high utilization throughout a significant portion of the day. These lots are generally concentrated near the Public Affairs Center (PAC) and Student Union. While the high parking utilization may influence student, faculty, and staff satisfaction and create additional traffic on the street network as drivers circulate to find a parking space, the parking utilization also affects adjacent properties. The high utilization observed in some areas likely created spillover into adjacent lots, which may have resulted in reduced parking capacity for other students, faculty, and staff. Despite the high utilization in some lots, the overall peak occupancy level suggests the campus provides ample opportunity to remove existing parking to accommodate other capital improvements. With modifications to the parking supply, strategies to address parking demand during special event conditions should be identified.

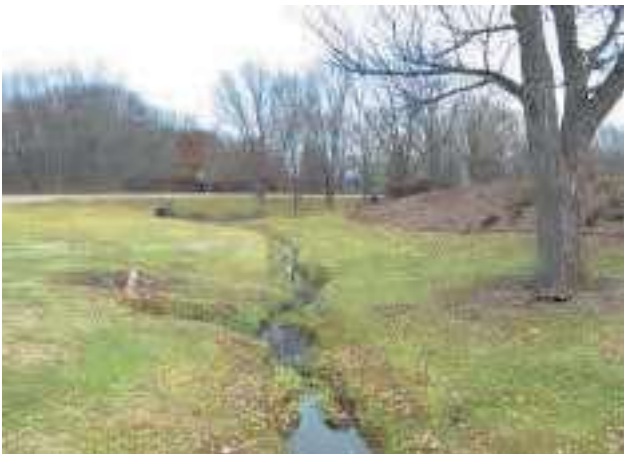
North Campus Drainageway

The southern half of campus drains to the south and east into a drainageway that flows through Lincoln Land Community College to the southeast and into Lake Springfield. The north half of campus drains to the north and east through a drainageway and into Lake Springfield beyond West Lake Drive. There is one stormwater retention pond on campus north of Brookens Library.

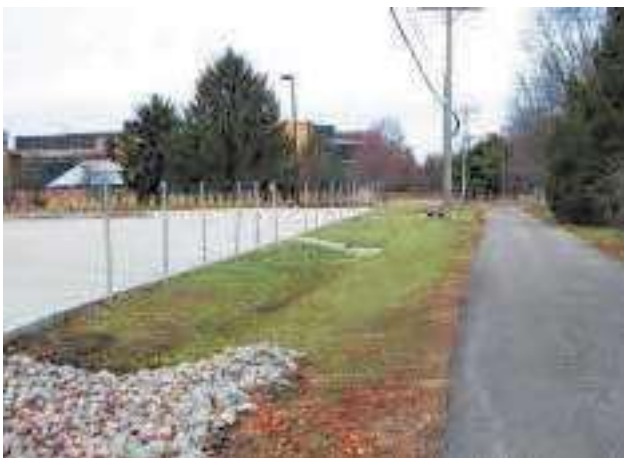
Currently, stormwater runoff is handled in several ways. In some areas, stormwater runs off hard surfaces into turf areas where it gradually percolates into the ground. Where there is an underlying tile system, the water can percolate more rapidly through the soil, into the tile where it will flow away from the area.

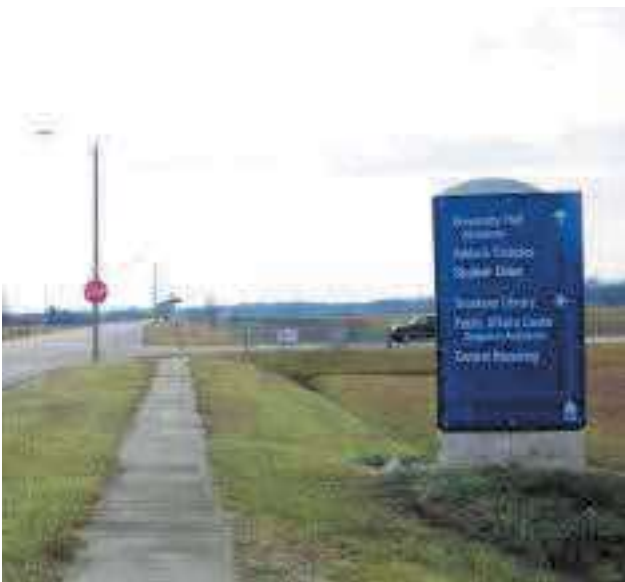
Sidewalks and bike lanes ending at Campus
Photos courtesy of Massie Massie + Associates.
