Volume 2b

Facilities & Campus Analysis

ANALYSIS OVERVIEW

Facility Condition Assessment: Architectural

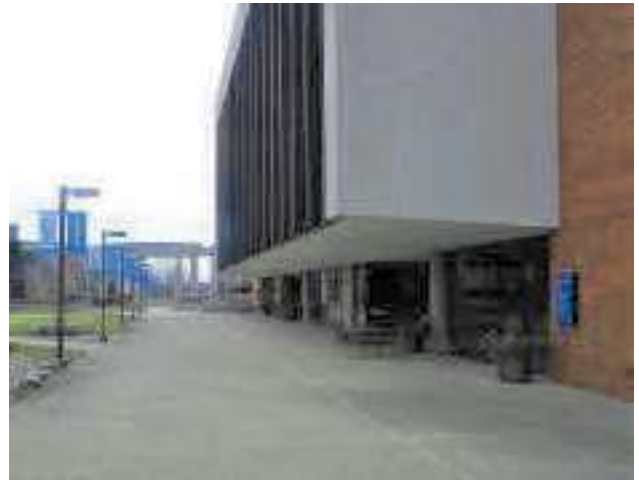
Lights and site furnishings at PAC

Over the years various styles of lights have been used. Several are still in evidence, although the University is working toward standardizing the fixtures. Recent site lighting and parking lights are LED. The older lights will likely be converted to LED in the future as fixtures are upgraded or replaced.

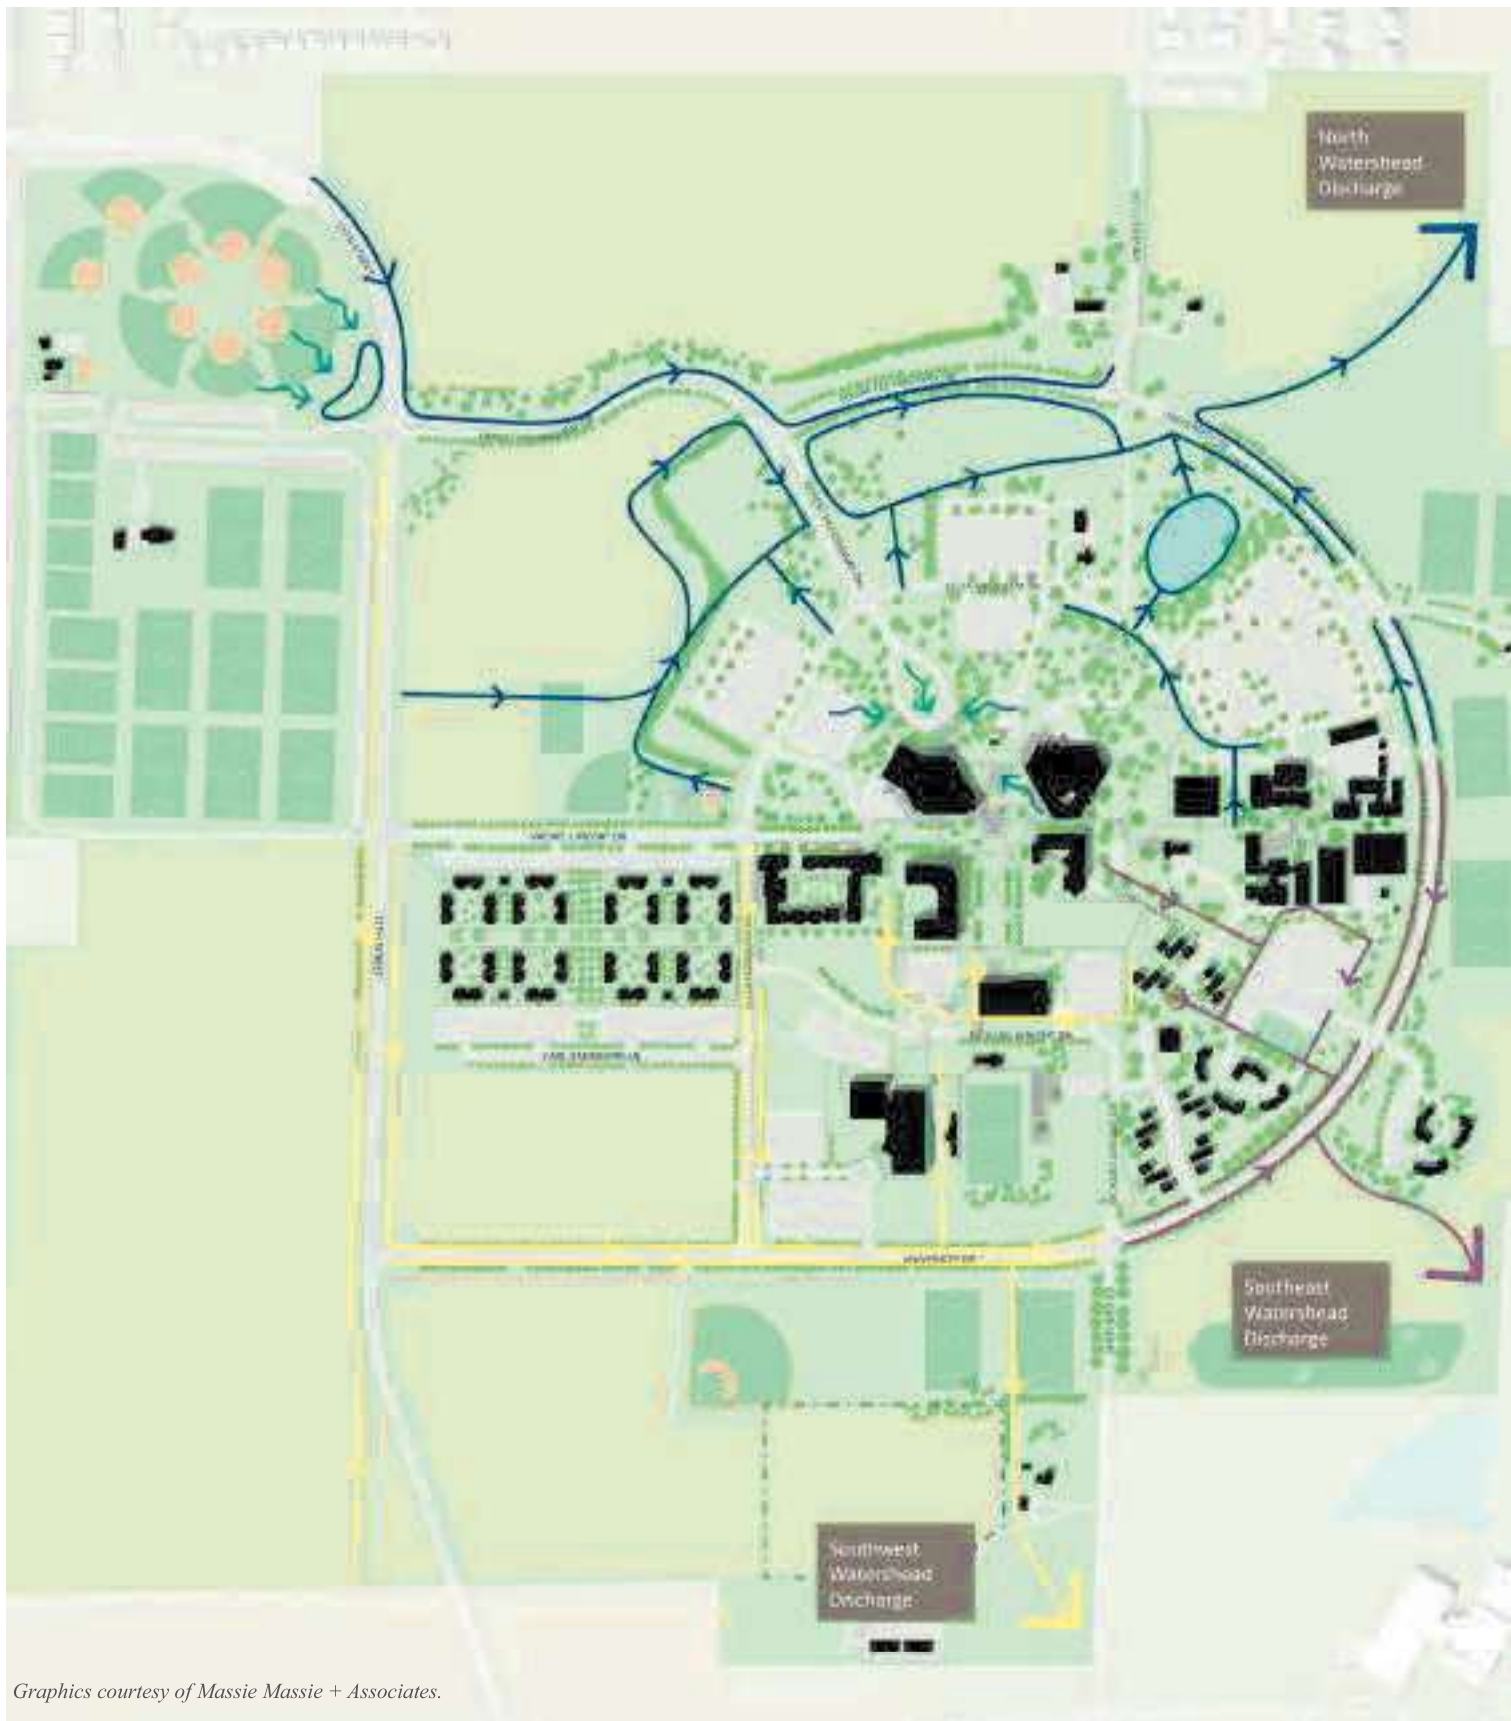
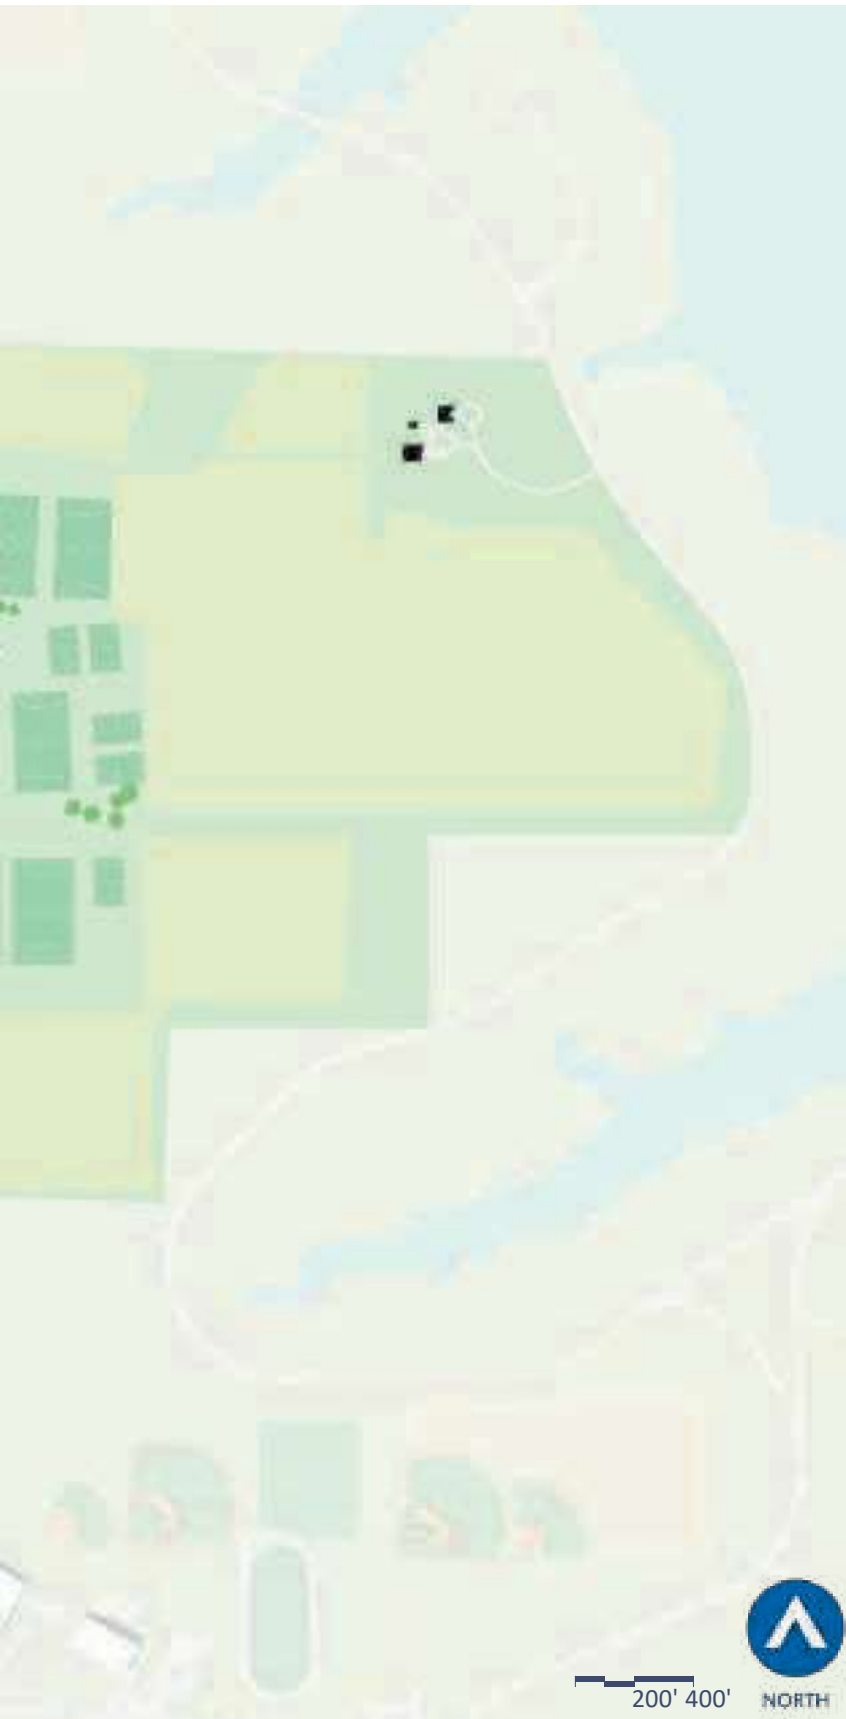
Topography & Drainage

As the campus develops in the future with new and expanded facilities the area covered by hard surfaces will no-doubt increase, adding to the challenge of managing stormwater drainage. It should be noted that green roofs on two existing buildings and the permeable paver surface on the Student Union plaza have helped reduce the amount of runoff.

Stormwater drainage of the campus and its effect on nearby Lake Springfield are concerns. Runoff from hard surfaces (rooftops, sidewalks, streets and parking lots) is

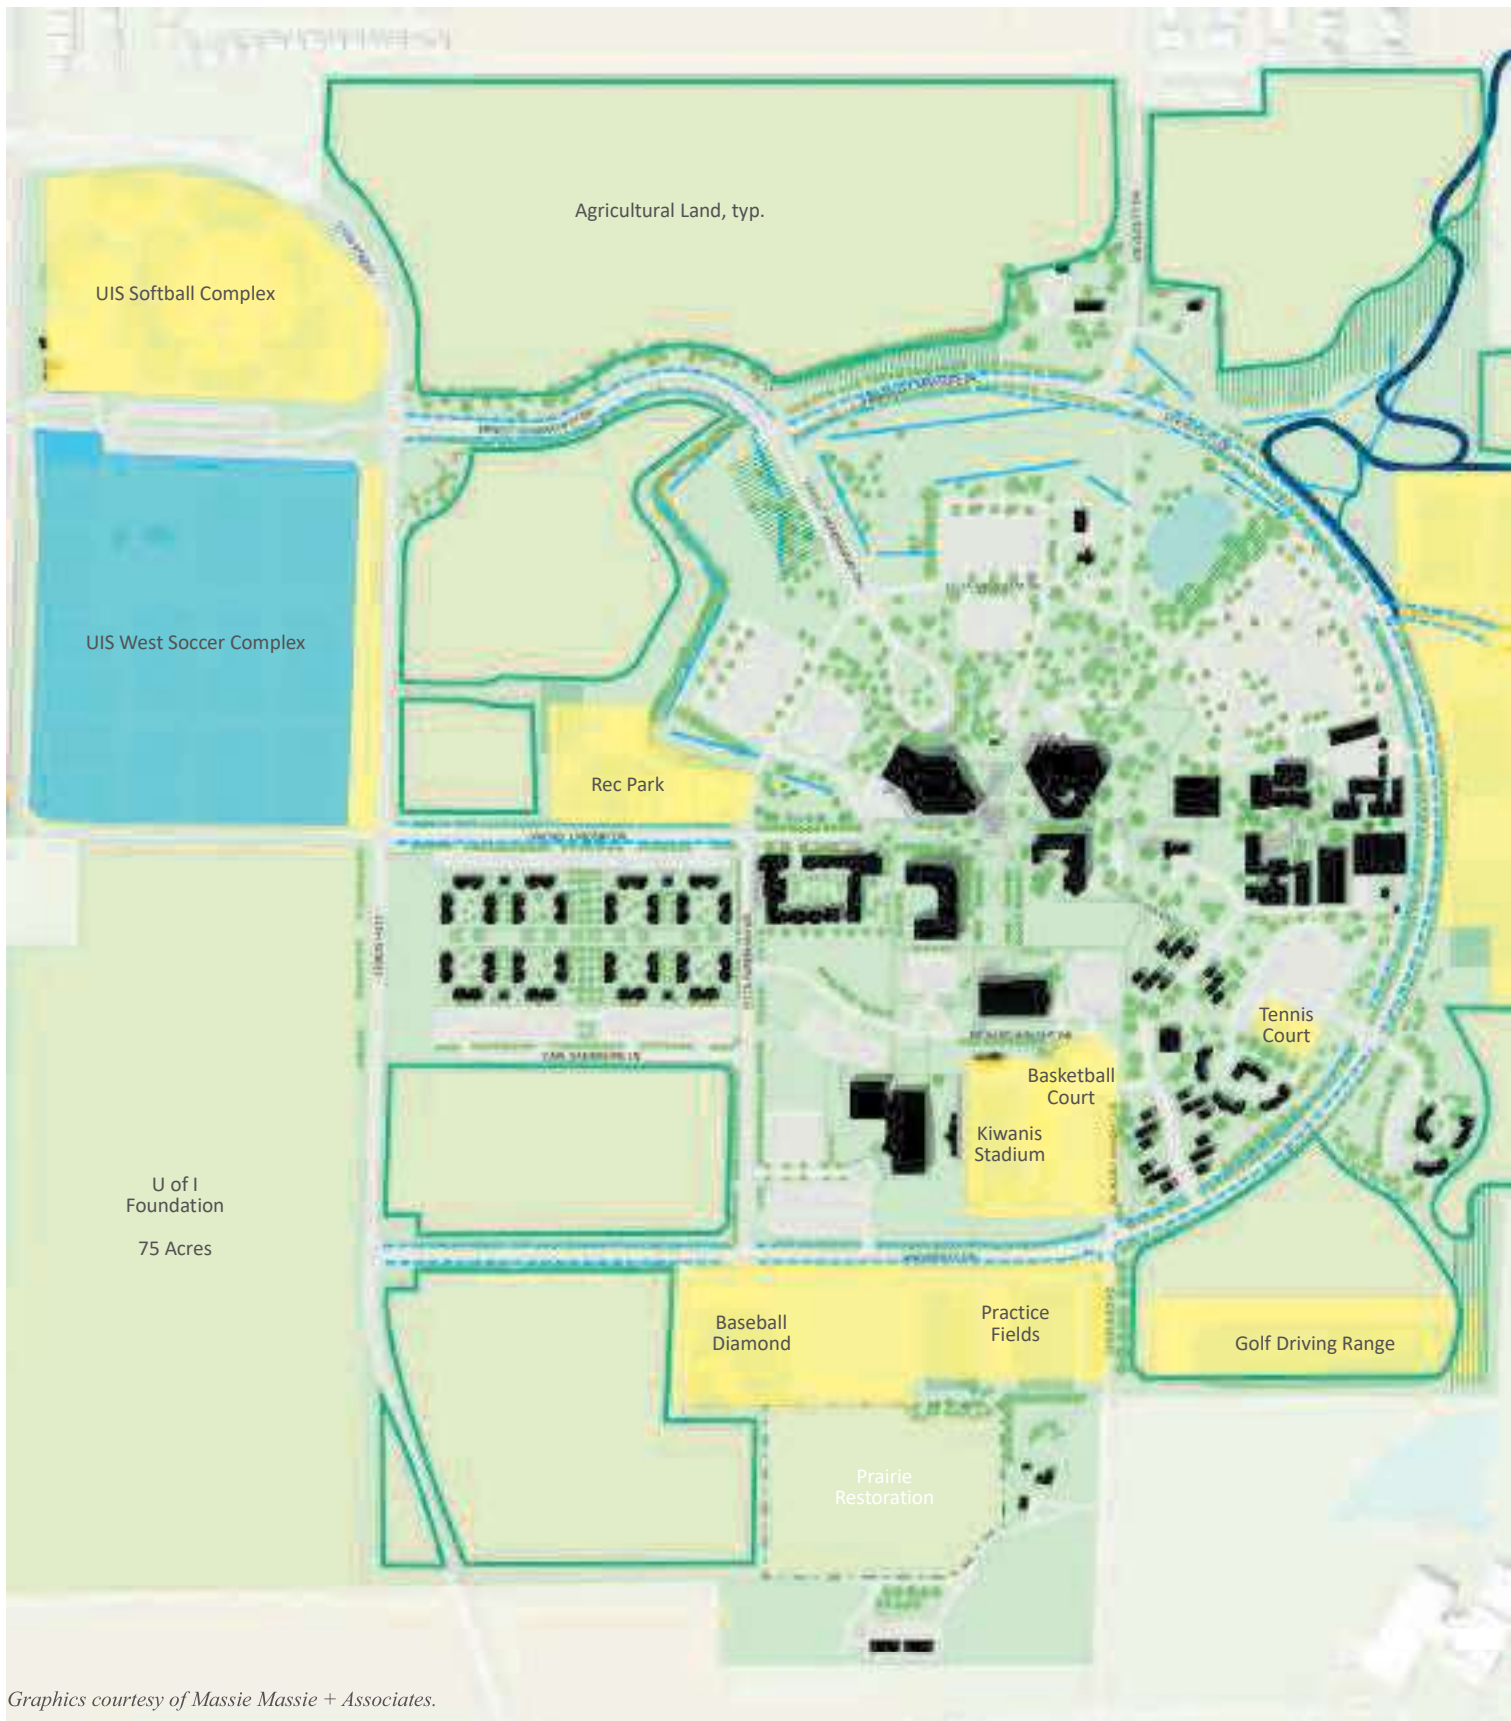
Campus Vegetation, Sports & Recreation

-   Sports or Recreation Field/Court
-   Disk Golf Course
-   Cross Country Trail
-   Agricultural Land
-   Mowed Turf
-   Prairie Restoration
-   Woodland
-   Tree-lined Streets

The large soccer field areas on the east and west sides of campus are leased to outside organizations. The YMCA runs the youth fields east of University Drive. The Springfield Area Soccer Association (SASA) operates additional fields on the west side of campus, west of 11th Street.

The UIS softball complex used by many community teams is also west of 11th Street. The fields are managed by the Land of Lincoln Junior Olympic Softball.

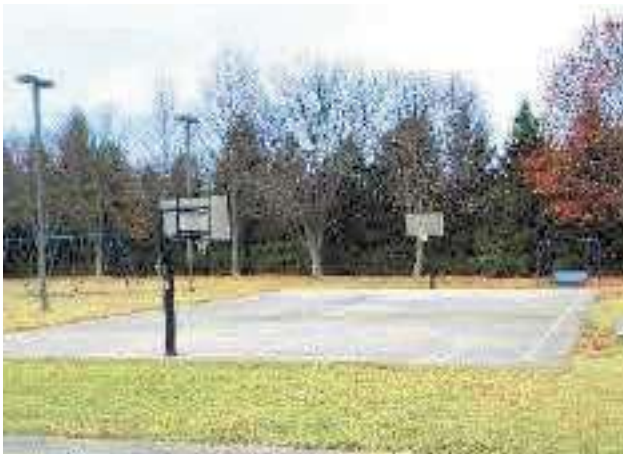
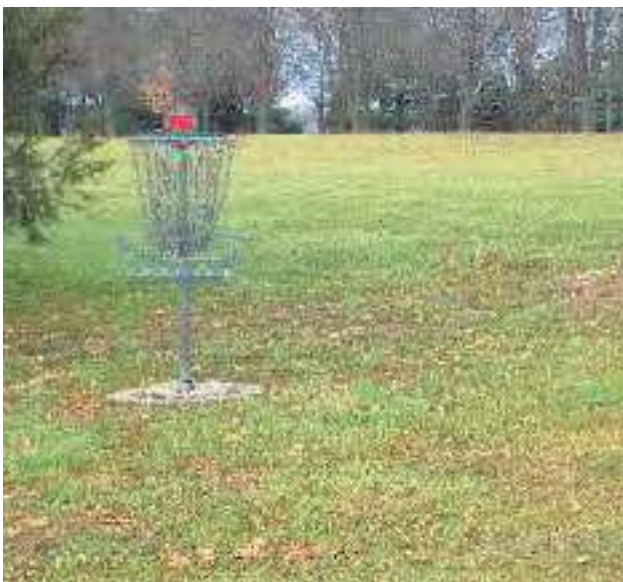
Basketball Court at REC Park

The new REC Park near the west student resident area provides a variety of facilities (sand volleyball, basketball, softball, and miniature golf). It is now somewhat exposed to climatic conditions.
